Manhole Inspection Summary

Manhole # S03YY1023MH

Insp Date: **8/14/06 12:00 AM**

Location Address: **3301 LUDGATE RD**

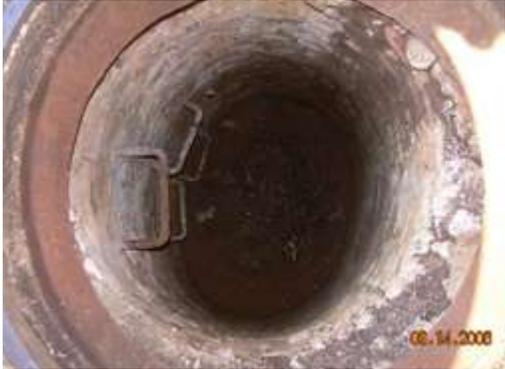
Top View

Barrel infiltration. Corroded steps. Channel debris.

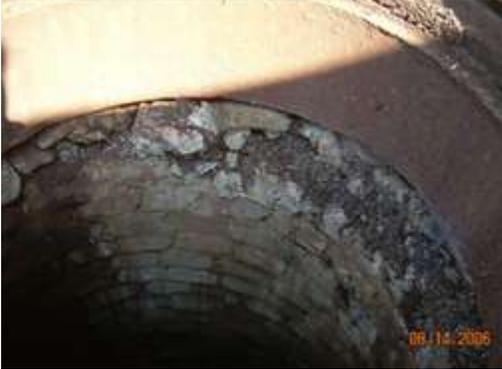
Defect

Frame leaks. Frame offset. Adjustment deterioration, loose brick, and infiltration. Corbel and Barrel infiltration.

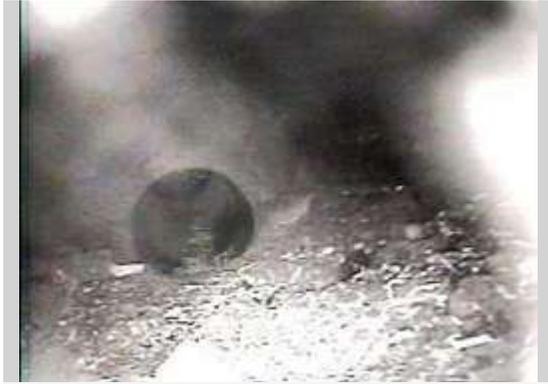
8 in. Circular Gravity Sewer
Pipe Out @ 12 O'Clock

Deposits: None **Mud** Sludge **Debris** Grease

Silt Depth: **1** (in.) Deposits Extent: **Light**
